Over 20 tonnes of Cocoon was used on salt affected masonry at St Mary's Cathedral.

TOTALLY COCOONED AUSTRALIAN-MADE POULTICE

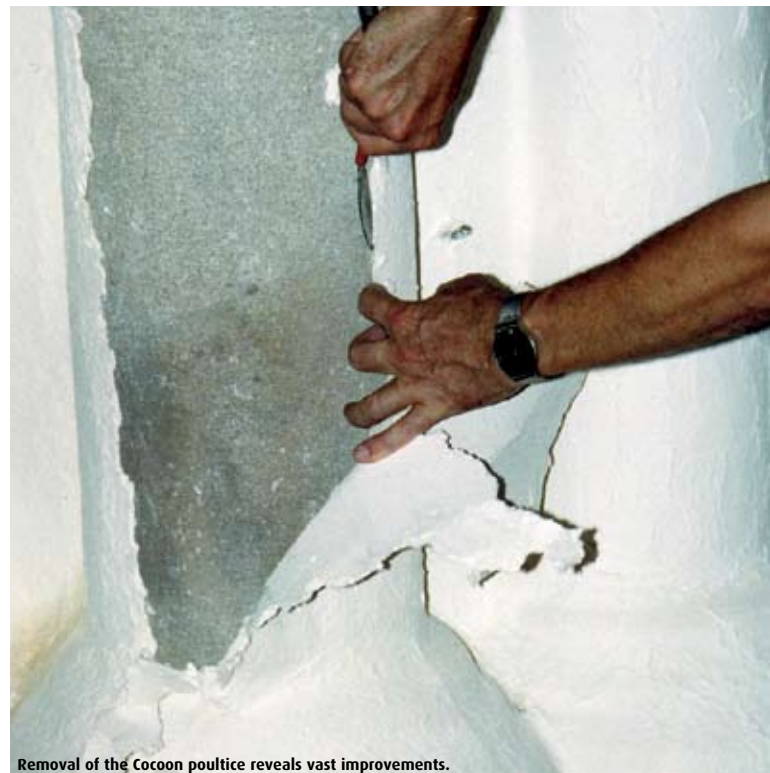
Removal of the Cocoon poultice reveals vast improvements.

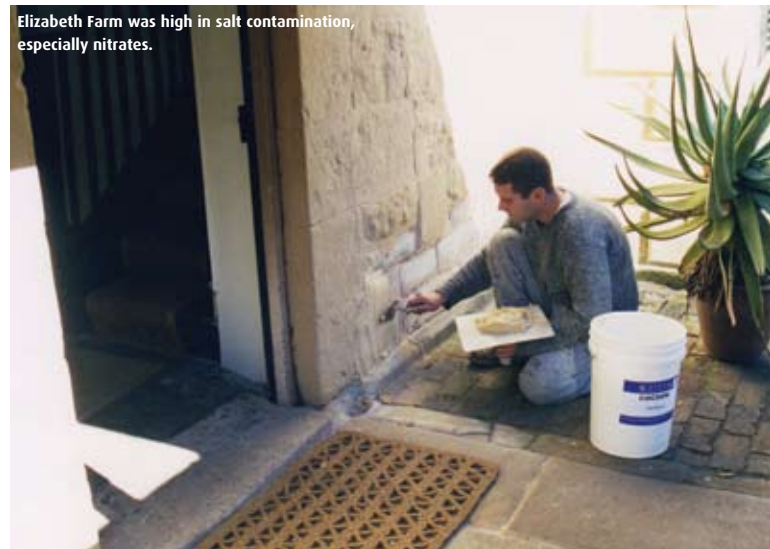
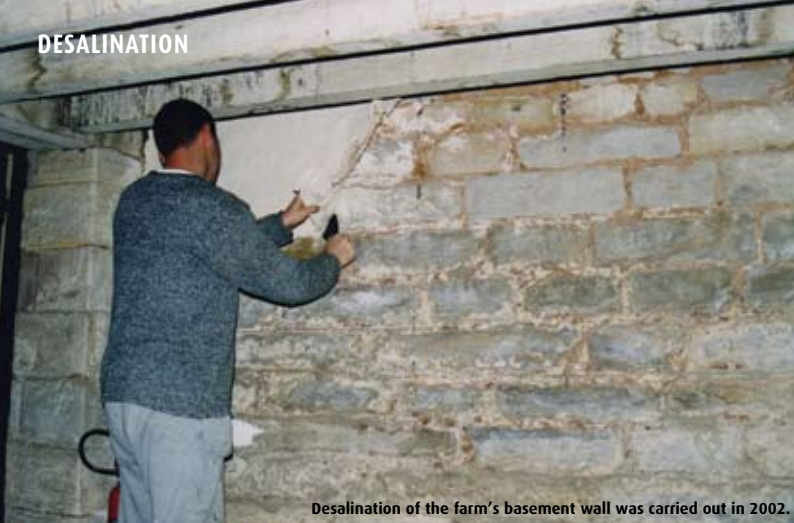
Elizabeth Farm was high in salt contamination, especially nitrates.

Desalination of the farm's basement wall was carried out in 2002.

One of the most successful applications to date has been at Australia's oldest European-style building, Elizabeth Farm, which was built in 1793 from Sydney sandstone.

The building was comparatively high in salt contamination, especially nitrates. Sacrificial renders have been used for some years along with traditional lime washes, and while these have helped slow the rate of decay, success has been limited.

In November 2002 Cocoon was used on a wall in the basement, which was below ground level and lime washed along with the other basement walls after the desalination work, the outside wall of the servants' quarters, which was also lime washed after desalination, and internal and external laundry walls, which had two types of sacrificial renders applied after the desalination work with a lime wash applied over the top.

All existing sacrificial render was removed prior to applying Cocoon so the original stone surface was exposed for desalination. In the areas that were originally lime washed, the stone was mostly exposed by the on-going exfoliation caused by the salt contamination.

Five year later, in February 2007, an inspection of the areas where desalination was carried out revealed only one small area of visible salt contamination in the laundry area where the sacrificial render was used, and another on the outside wall of the servants' quarters where the lime wash was used.

All other areas, including the basement, had no visible signs of salt action. Even the flagstones on the verandas, which were deteriorating at a rapid rate, showed no signs of exfoliation after the Cocoon treatment.

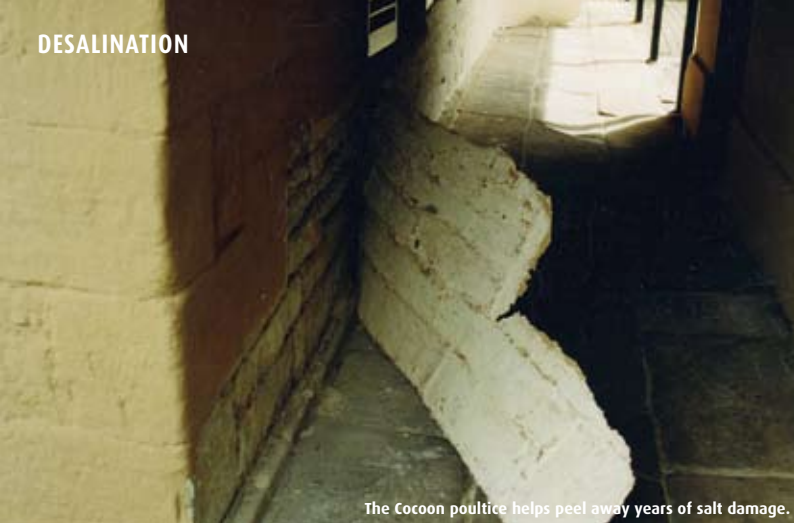
The Cocoon poultice helps peel away years of salt damage.
