# Attack of the Stylolites...!

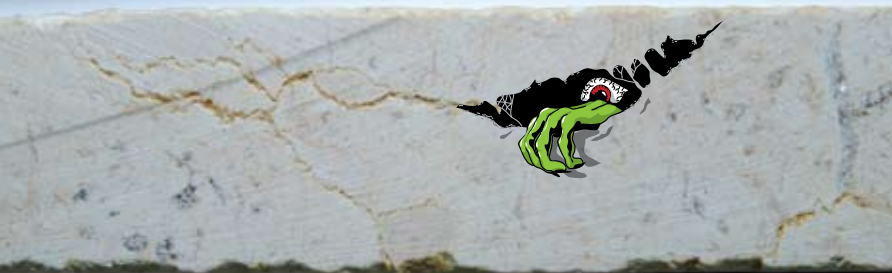
Fig 1a

stylolites in polished beige limestone of the floor of the lobby of the Crowne Plaza Hotel in Canberra.

**Figures 1–3 (below)**: Close-up of typical stylolites in polished limestone of the lobby floor; general view of the lobby; close-up emphasising depth, not a defect unless extending to depth of slab. Crowne Plaza Hotel

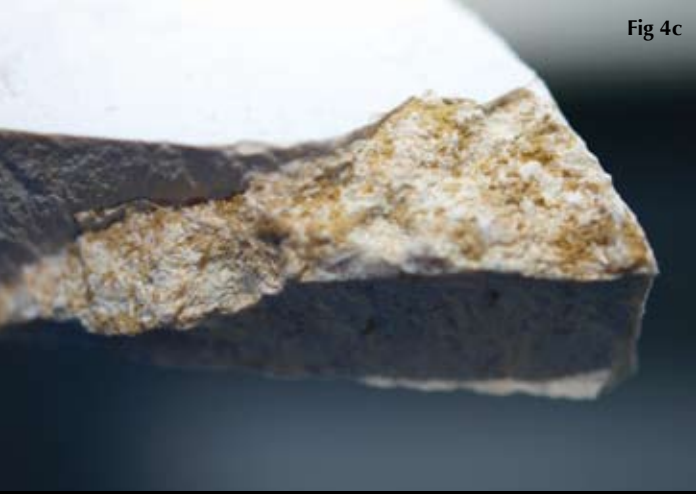
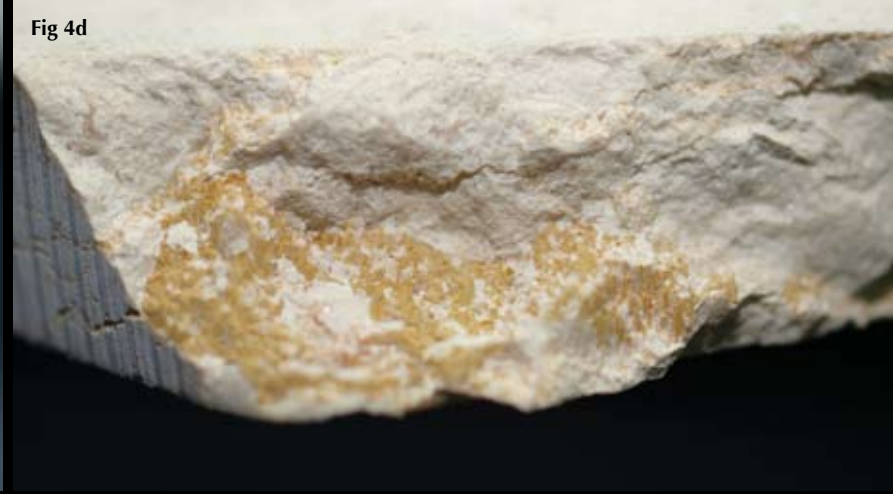
**Figures 4a-d (above)** : Close-up of brown stylolite seams exposed at edges of slabs of 30mm thick French limestone used for cladding of apartments in Hong Kong.

**Figures 4 to 6** are close views of fractures in 30 mm thick slabs of a beige French limestone used as veneer cladding on luxury apartment buildings at The Peak in Hong Kong. Within a year of completion, hundreds of limestone panels displayed full-depth cracks along open stylolites, breakages where stylolites intersected finished surfaces at shallow angles and spalls where stylolites coincided with or passed close to holes drilled for stainless steel dowel pin-fixings. After seven days of immersion in water, some samples of pristine limestone slabs from the same source could be forced apart by hand. During a protracted law suit instigated by the owner and developer of the apartments, the

judge concluded that the limestone selected and recommended by the architect and project manager was not fit for its intended purpose; these weak brown seams were rightfully classified as examples of *Bad Stylolites*. Curiously, the small samples of stone, submitted for testing soon after stone selection was approved, were described by the testing agency as *grey limestone* containing no features that resembled stylolites.<sup>NOTE 1</sup>

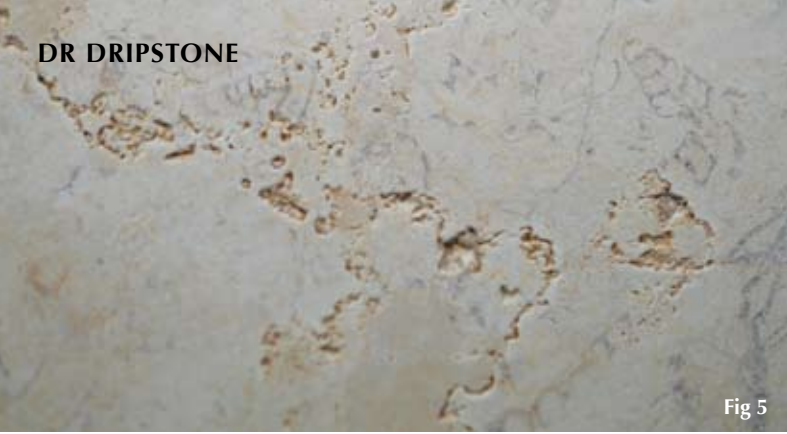
Fig 5

**Figure 5.** A stylolite, roughly parallel to the bedding plane of the same French limestone, outcropping at a honed surface.

**Figure 5 (next page)** A stylolite, roughly parallel to the bedding plane of the same French limestone, outcropping at a honed surface.

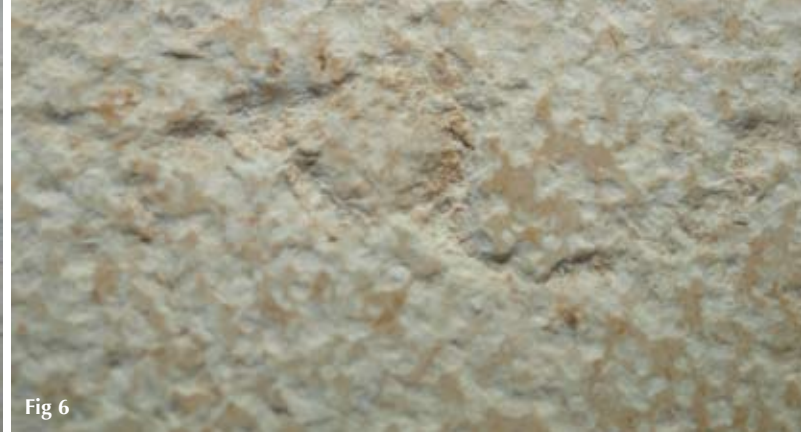
Fig 6

**Figure 6.** A similar but more cunning stylolite made less visible by the bush-hammered finish.

**Figure 6. (next page)** A similar but more cunning stylolite made less visible by the bush-hammered finish.

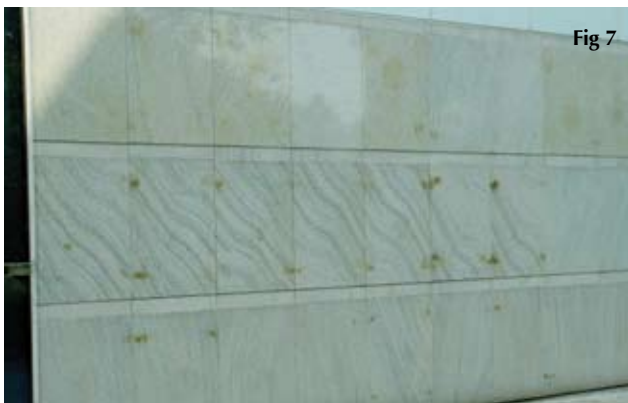
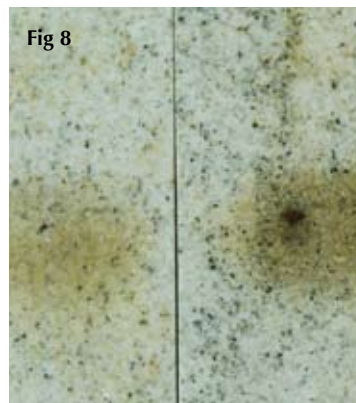
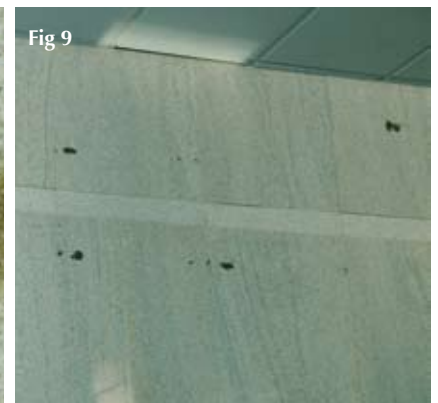
**Figures 7** show examples of progressively worsening brown staining of polished and honed granite on walls at the base of a four-storey electronics factory and attached offices in Singapore. The staining was first noticed within a year of completion of the building in 2002; these photographs were taken in 2009. Stains occur wherever an unidentified epoxy resin has been used (1) around stainless steel angle fixings that engage slots cut into the rear faces of stone panels, and (2) as flattened pads between stone and the underlying concrete blockwork wall. **Figure 8** is a close view of two of these stains. Their colour and spread change with exposure to rain and sunlight; where completely sheltered under the porte cochere (**Figure 9**), the stains are almost black and much smaller and display distinct edges. The most remarkable aspect of this daunting detail is the explanation initially offered by an expert witness acting of behalf of the building contractor; the stains were, he declared, a natural and unavoidable feature of the stone. Dr. Dripstone is interested in feedback – via the ever-obliging editor of *Discovering Stone* – from those who have seen and can explain similar staining.
