SYDNEY YELLOWBLOCK IS ITS REVIVAL A BLESSING OR A CURSE?

JASPER SWANN investigates how the recent stockpiling of yellowblock sandstone is causing a collision between principles and practice in the conservation of Sydney's prominent sandstone buildings, and explores some alternative approaches.

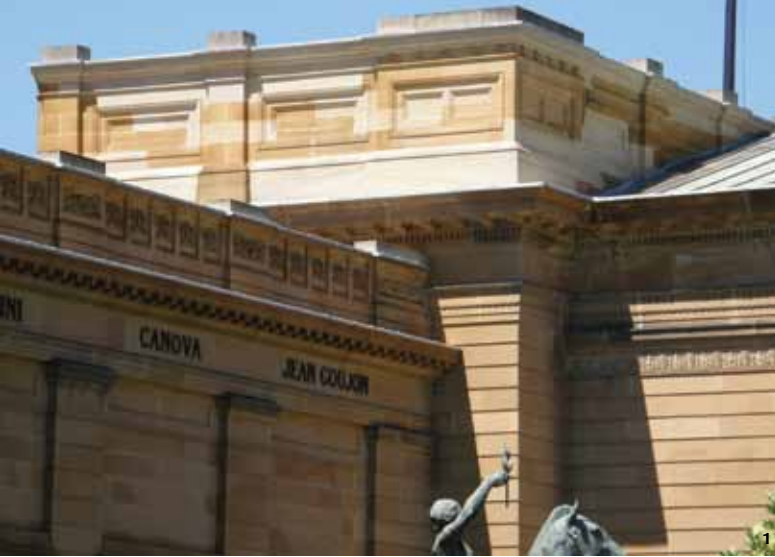
Photo 1: Art Gallery of New South Wales, restored using Capricorn Custom Buff. Photo 2: Darlinghurst Law Courts, Sydney. Photo 3: Replacement of the cornice and balustrade at the Australian Museum. (Photos: Jasper Swann, 2007)

A subsequent dalliance with a Queensland stone, Capricorn Custom Buff, for a number of significant buildings, such as the Art Gallery of New South Wales and Sydney University Quadrangle Building, produced outcomes that couldn't really be said to be satisfactory. The Custom Buff may have been a good quality stone, and it may have been a perfect match for the nineteenth-century buildings of Rockhampton and certain colour-stable stones around Australia, but it was far from being a suitable match for Sydney yellowblock, as inspection of either of those buildings will reveal.

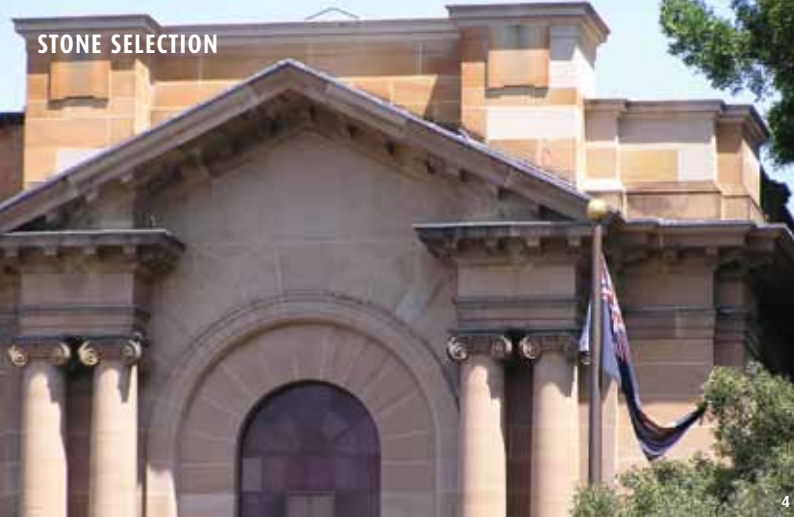
Photo 4: Replacement stone in the parapet at the State Library of NSW. Photo 5: Wholesale replacement of stone in the pediments, tower and balustrades of Sydney Observatory. Photo 6: McCaffrey's stone in the Anderson Stuart Building, University of Sydney. (Photos: Jasper Swann, 2007)

Replacement of small quantities of stone can also be disfiguring. New stones introduced at the State Library of NSW and the Anderson Stuart Building at the University of Sydney are conspicuous in their stark unsuitability.

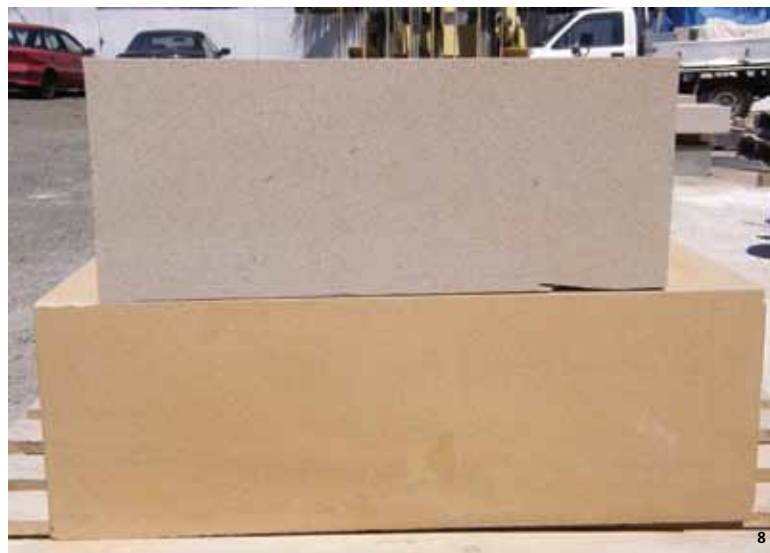
Photo 7: Guinea Gold stone used for the new portico at Sydney Grammar School. **Photo 8:** A piece of McCaffrey’s (top) above a piece of Guinea Gold, eight weeks after sawing. **Photo 9:** Irregular manganese staining on a piece of Guinea Gold and (**photo 10**) its removal using a weak hydrochloric acid solution. (Photos: Jasper Swann, 2007)

The new portico built on the College Street façade of Sydney Grammar School in 2001 – immediately alongside the Australian Museum – provides a particularly useful example of just how good a match the Guinea Gold can be.

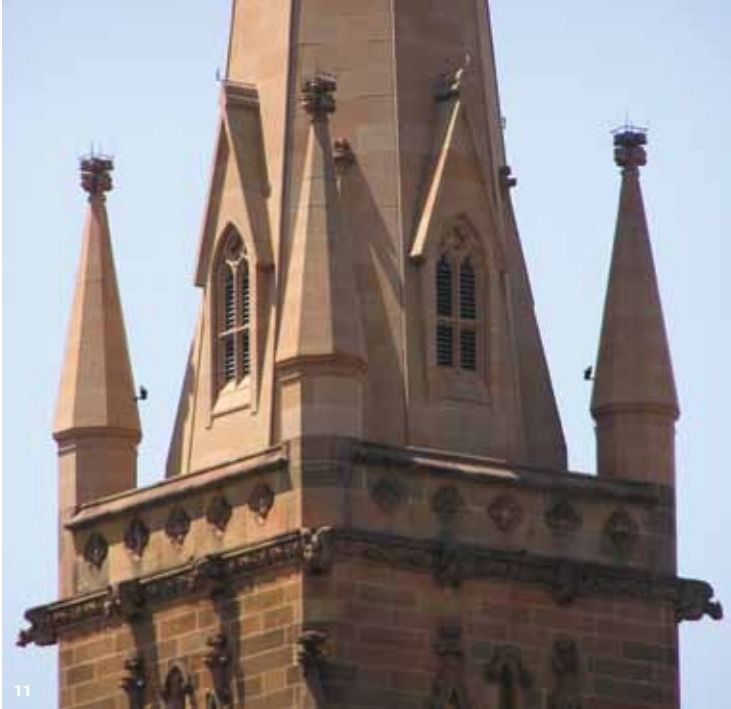
Photo 11: The new spires of St Mary's Cathedral, Sydney – Wondabyne stone.
Photo 12: A piece of McCaffrey's stone artificially and permanently coloured.
(Photos: Jasper Swann, 2007)

In 1983, Gosford Quarries and Amdel developed a method of simply and permanently colouring such stones to match their successfully oxidised counterparts. The method, which is commercially protected, has been used extensively on a large number of buildings over many years and appears to have no shortcomings. The penetration of the colouration is very similar to the depth of a naturally oxidised surface (1–3 mm); the effect is permanent; and the solution applied is harmless to the stone, producing by chemical reaction the same surface chemical compound as would naturally occur in the oxidisation of a yellowblock stone. Applied with a brush or sponge, it is also harmless to the person applying it. Most in the industry will be aware that the Wondabyne stone from which the new spires of St Mary’s Cathedral are built is naturally as grey as an elephant’s hide. The application of the Gosford Quarries’ colouring solution here has been overwhelmingly successful in a situation where the need for a good colour match was essential. The same method was also successfully used to colour Wondabyne stone in the restoration of the eastern façade of Sydney Town Hall in 1992.
